Laramie County Fire Authority Community Assessments

Appendix B – Community Assessments

Laramie County Fire Authority

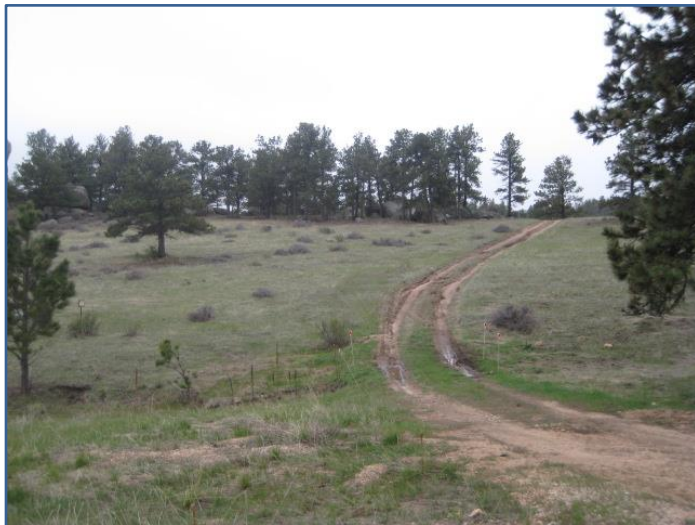
Narrow two-track road

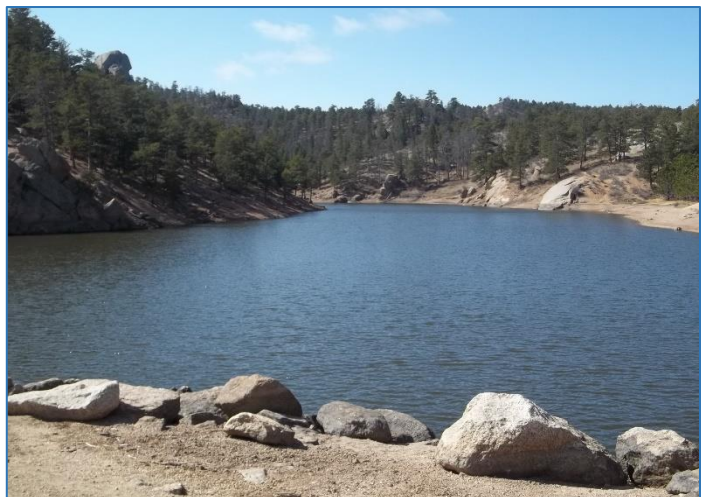
Pine Forestland in Crow Creek Canyon at west end of Granite Springs Reservoir

forestland between them and the lake with steep topography and drainages making fire behavior more hazardous to structures.

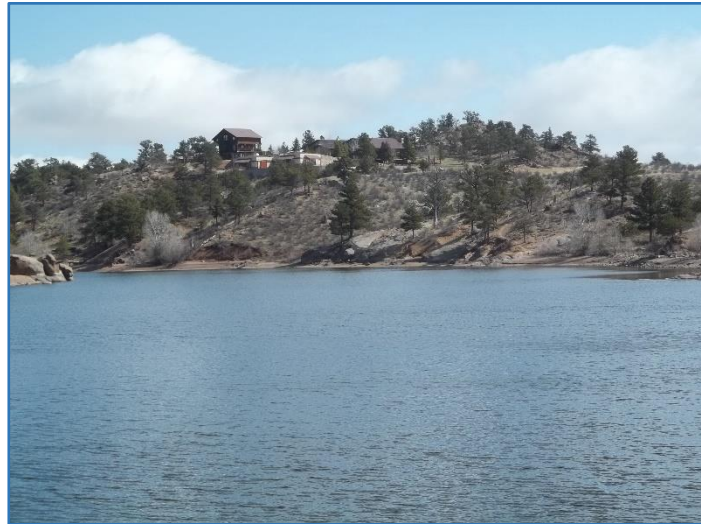
- A large component of standing dead and down woody fuels
- The live conifers have a low crown base height
- There are homes located above the reservoir in potentially hazardous locations
- Long response times and minimal resources for initial attack
- Reduction in water quality in the event of a wildfire on lands upstream of the reservoirs

Homes above Granite Springs Reservoir

- Thin pine stands to a target density of 60 square feet of basal area per acre when over eight inches average stand diameter. Below eight inches average diameter, thin to 175 trees per acre. Slash should be hand-piled and burned when there is at least 4 inches of snow or ground conditions are moist, or chipped and scattered. Chip depth should not exceed 3 inches.

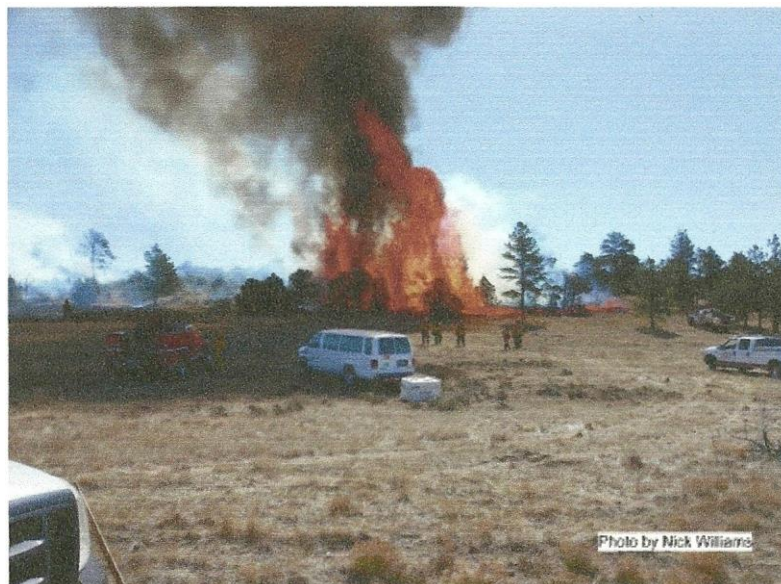
Anticipated fire behavior of a moderate to severe wildfire in vegetation similar to GSR

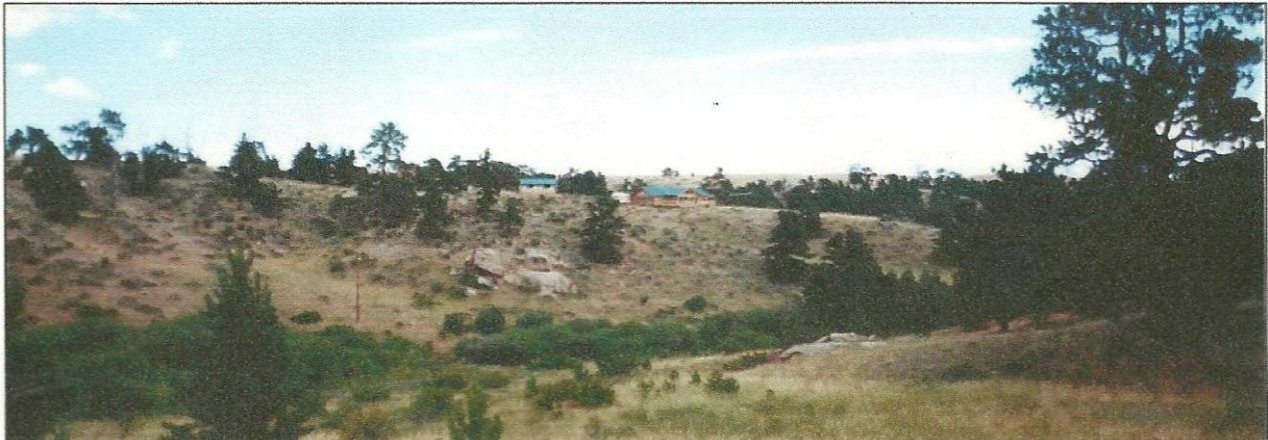
Typical vegetation, fuels, and topography found in the community area

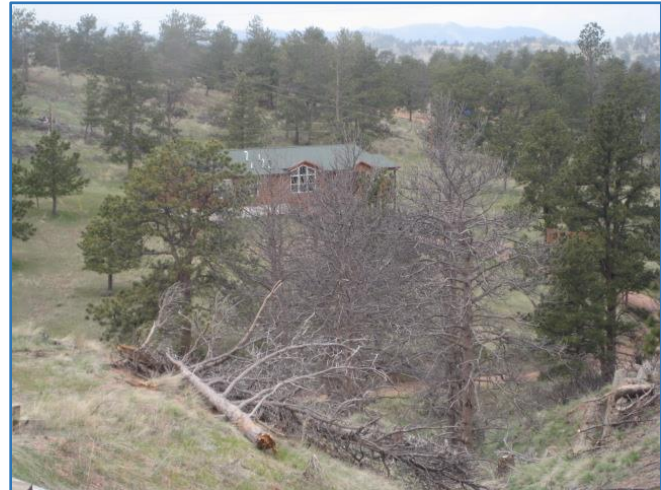
Home in chute with heavy dead fuels
