Laramie County Fire Authority Community Assessments

Appendix B – Community Assessments

Laramie County Fire Authority

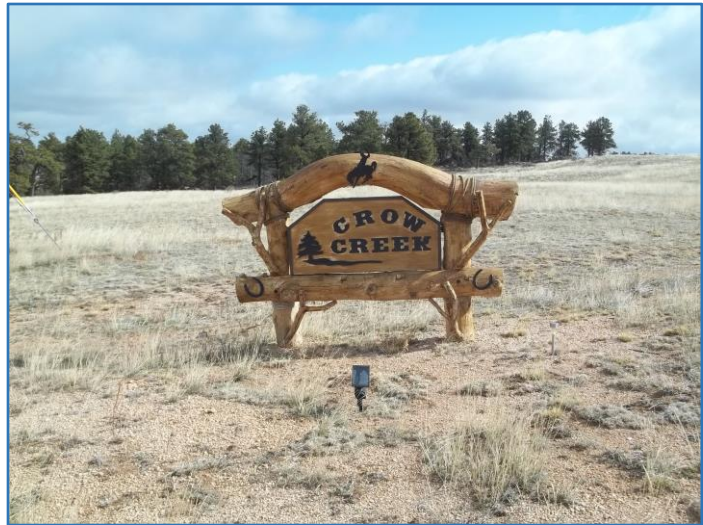
Narrow two-track road

Roads and Access: Roads in the community are native surface. Grades as steep as 10% were found, with poor alignment for large trucks or semi-trailers. Road width varies, with 1 to 1 ½ lane roads with drained prisms close to the entrance, deteriorating to two-tracks with no drainage farther into the subdivision. Cul d' sacs have limited to no turnaround area. There is one access point to County Road 210 from the community.

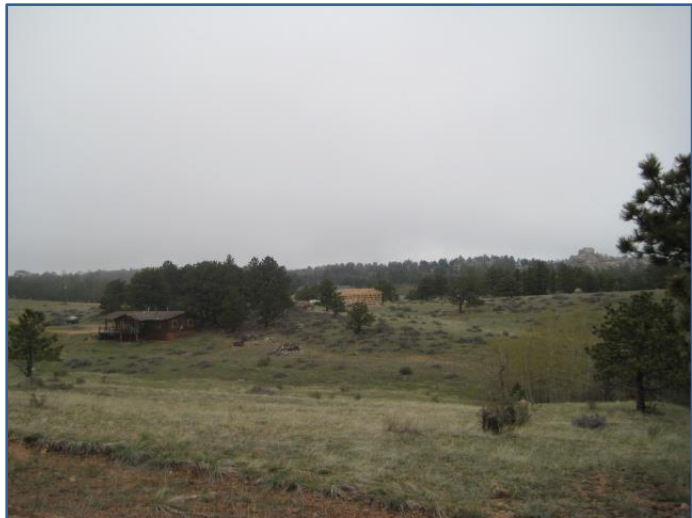
Crow Creek Landscape

- No reflective address signs (lot #'s)
- A large component of standing dead and down woody fuels in forested areas
- The live conifers have a low crown base height
- There are home located at the tops of chutes
- No hydrants or additional water storage, and
- Long response times and minimal resources for initial attack

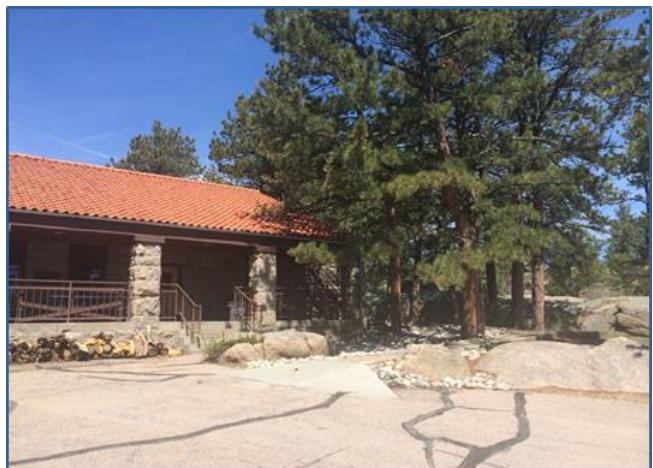
Historic Hynds Lodge

Hynds Lodge, which is operated by Wyoming State Parks, is listed on the National Register of Historic Places. Various groups use the lodge, which can accommodate meetings and has the ability to sleep approximately 20 people. The lodge is built partially into a hillside and is constructed of granite stone and masonry with a tile roof. There is also an amphitheater and other day-use areas in close proximity to the lodge.

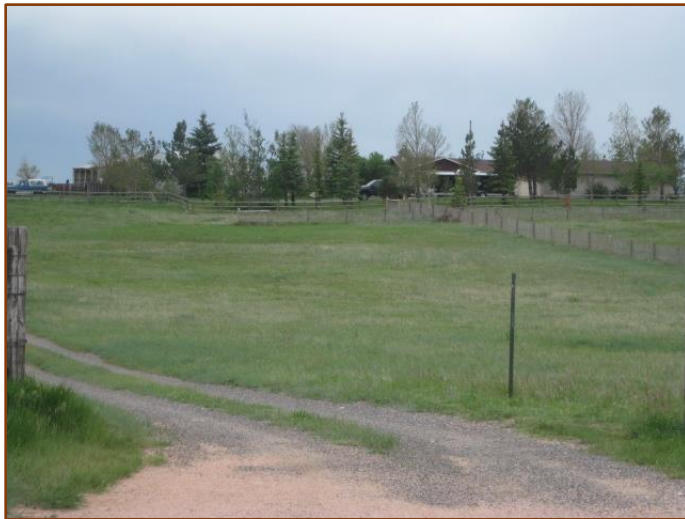
Wildfire Risk: The most likely ignition sources would be from a house or chimney fire. There is also the possibility of a lightning-caused grassland fire moving into the subdivision.

Roofs and siding construction materials are fairly fire resistant. There was minimal vegetation within Zone 1, though some structures did have shrubs or flammable materials stored within Zone 1. Since the subdivisions are 20 or more years old,

trees and shrubs are found within 30 feet of some houses.

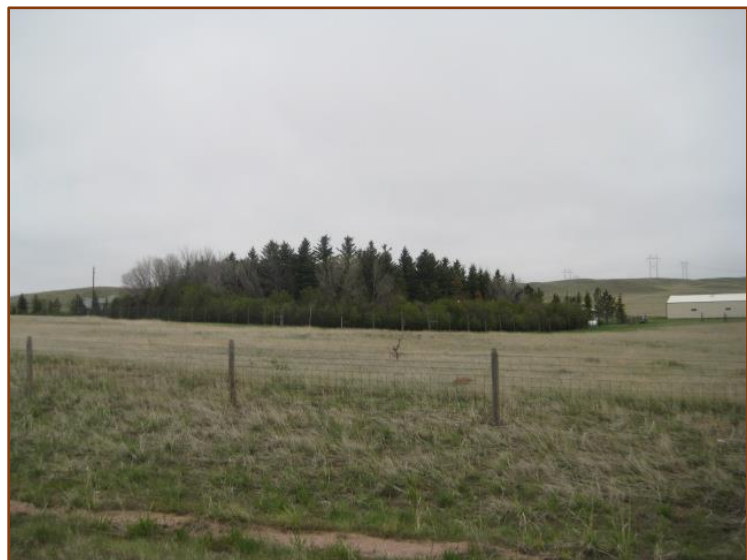
Wildfire Risk: A structure or chimney fire is the most likely ignition sources. There is also the possibility of a lightning-caused grassland fire moving into the subdivisions. Two recent fire scars of two acres or less were noted during on-site visits in the summer of 2015. No structures were significantly damaged.

Roofs and siding construction materials are generally fire resistant, most often dependent on surrounding vegetation near the structures. There is usually good defensible space within Zone 1, though some structures do have shrubs or flammable materials stored within Zone 1. Trees and shrubs are found within 30 feet of some houses, providing sources for spotting and more intense fires close to structures.

Keeping grasses mowed, especially as they dry out, can help provide fuel breaks around the homes. With FireWise mitigation put into practice in Zones 1 and 2, individual homes will provide safe structures to shelter in place should there be a fast-moving grass fire in the area.

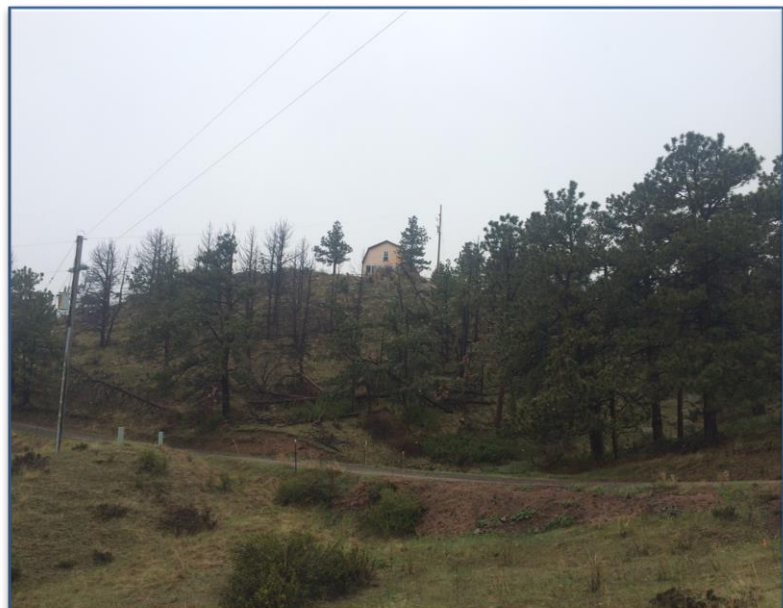
Some homes have timber and shrubs within Zone 2, where fire could be problematic due to steep and complex topography.

- Thin overstocked stands to a crown spacing of 10 to 12 feet and remove large (3 inch + diameter) downed dead wood within forested areas.
- Prune conifers up 8-10 feet in Zones 1 and 2 around structures and replace flammable vegetation within 5 feet of structures with fire-resistant vegetation and/or non-flammable mulches.

- Mow 100 feet wide or to lot boundary around homes in grassland areas.
- Develop firefighting water storage/use capabilities in several locations in subdivision.

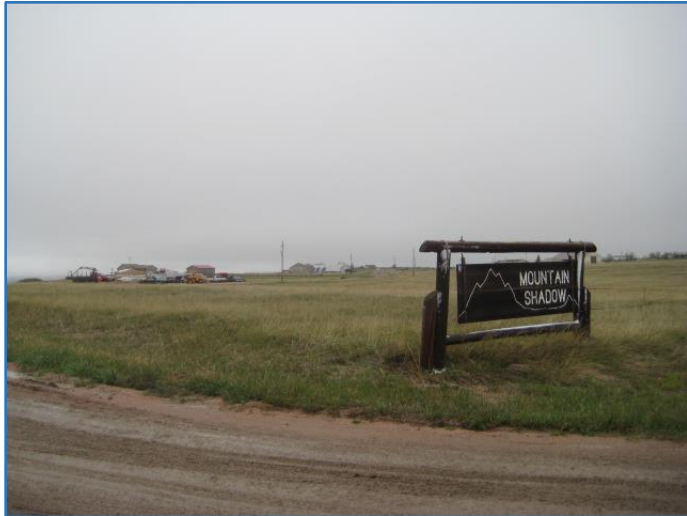
Mountain Shadow subdivision looking southwest

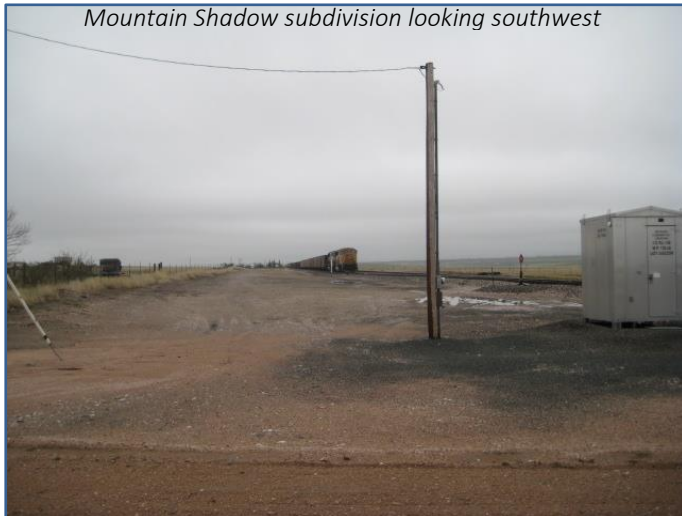
Federal Townsite looking south

and asphalt shingle roofs. The other is masonry with asphalt shingle roof. There is a significant amount of old vehicles and equipment within 100 feet of the residences. The townsite is platted for 28 lots. The BNSF Railroad lies immediately to the west of the townsite.

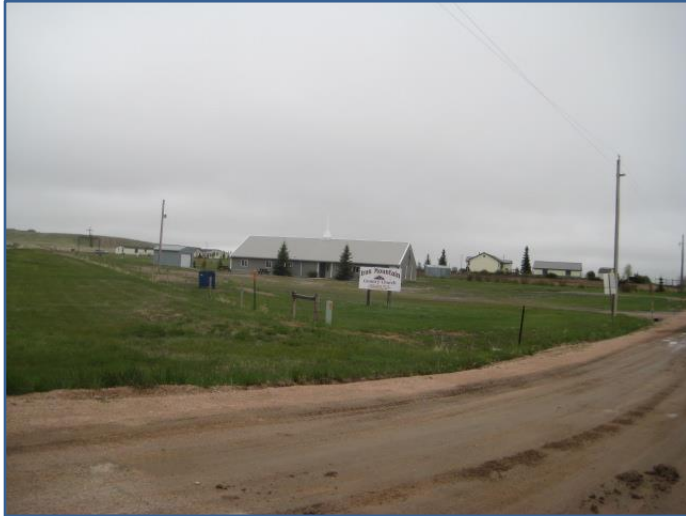
The Iron Mountain Church parcel lies on the southwest side of Highway 211 where the BNSF railroad R-O-W crosses the highway. The church and one outbuilding are the only structures but there is an historic cemetery to the southeast of the church. The church has a graveled parking area to the north. The building is metal-sided with a metal roof.

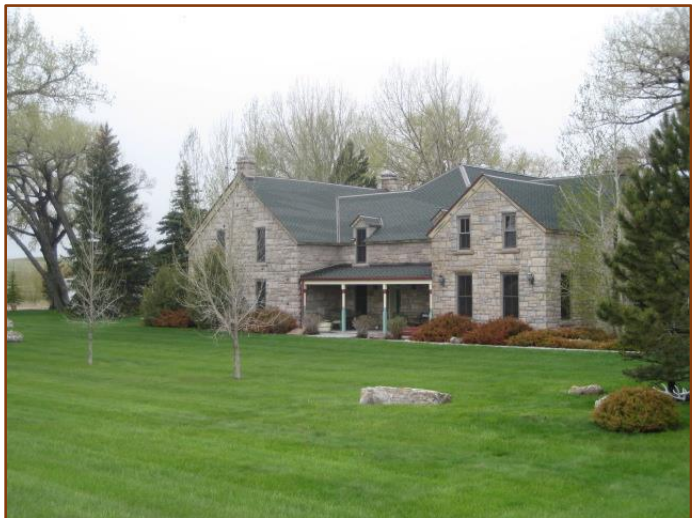
Roofs and siding construction materials are usually fire resistant with some exceptions, though some structures do have shrubs or flammable materials stored within Zone 1. Since the homes are 10 or more years old, trees and shrubs are found within 30 feet of the houses.

Keeping grasses mowed, especially as they dry out, can help provide fuel breaks around the homes. With Firewise mitigation put into practice in Zones 1 and 2, individual homes will provide safe structures to shelter in place should there be a fast-moving grass fire in the area.

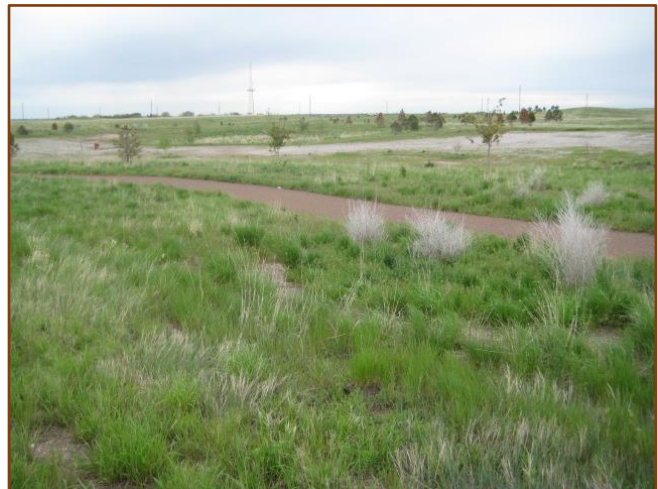
North Range Business Park Open Space

There is dedicated open space with walking trails in the northeast corner of the business park. Trees have been planted there but the current fuel model is still GR2. As the trees grow the fuel model will change to one more like TU4 –Dwarf Conifer with Understory, with more vertical fuels and increased risk of spotting.

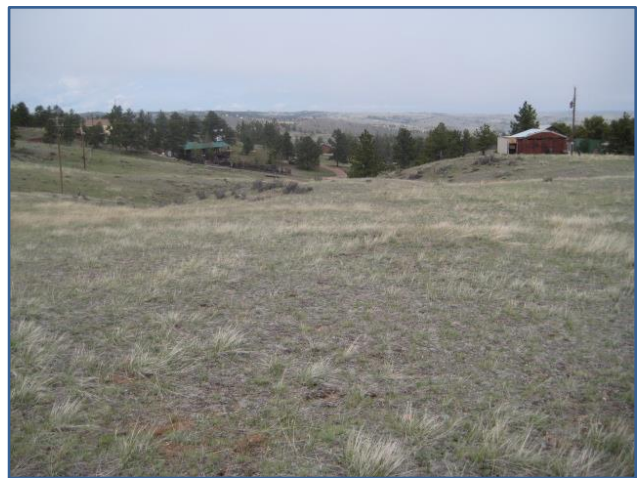
Pine Grove Landscape

Some homes have continuous fuels, primarily trees and shrubs, within 30 feet of the structure (Defensible Space Zones 1 and 2), where fire could be problematic due to ember showers and radiant heat.

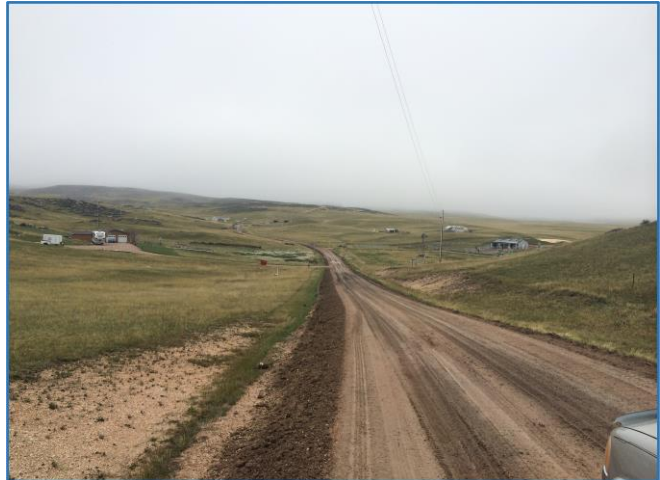
Looking into the Table Mountain community

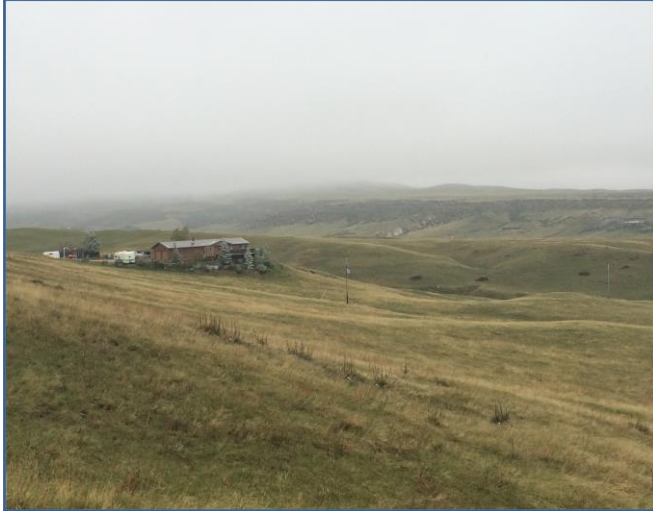
Areas of rolling hills could be susceptible to fast moving grass fires.
